Volvo L120C

Machine Visibility

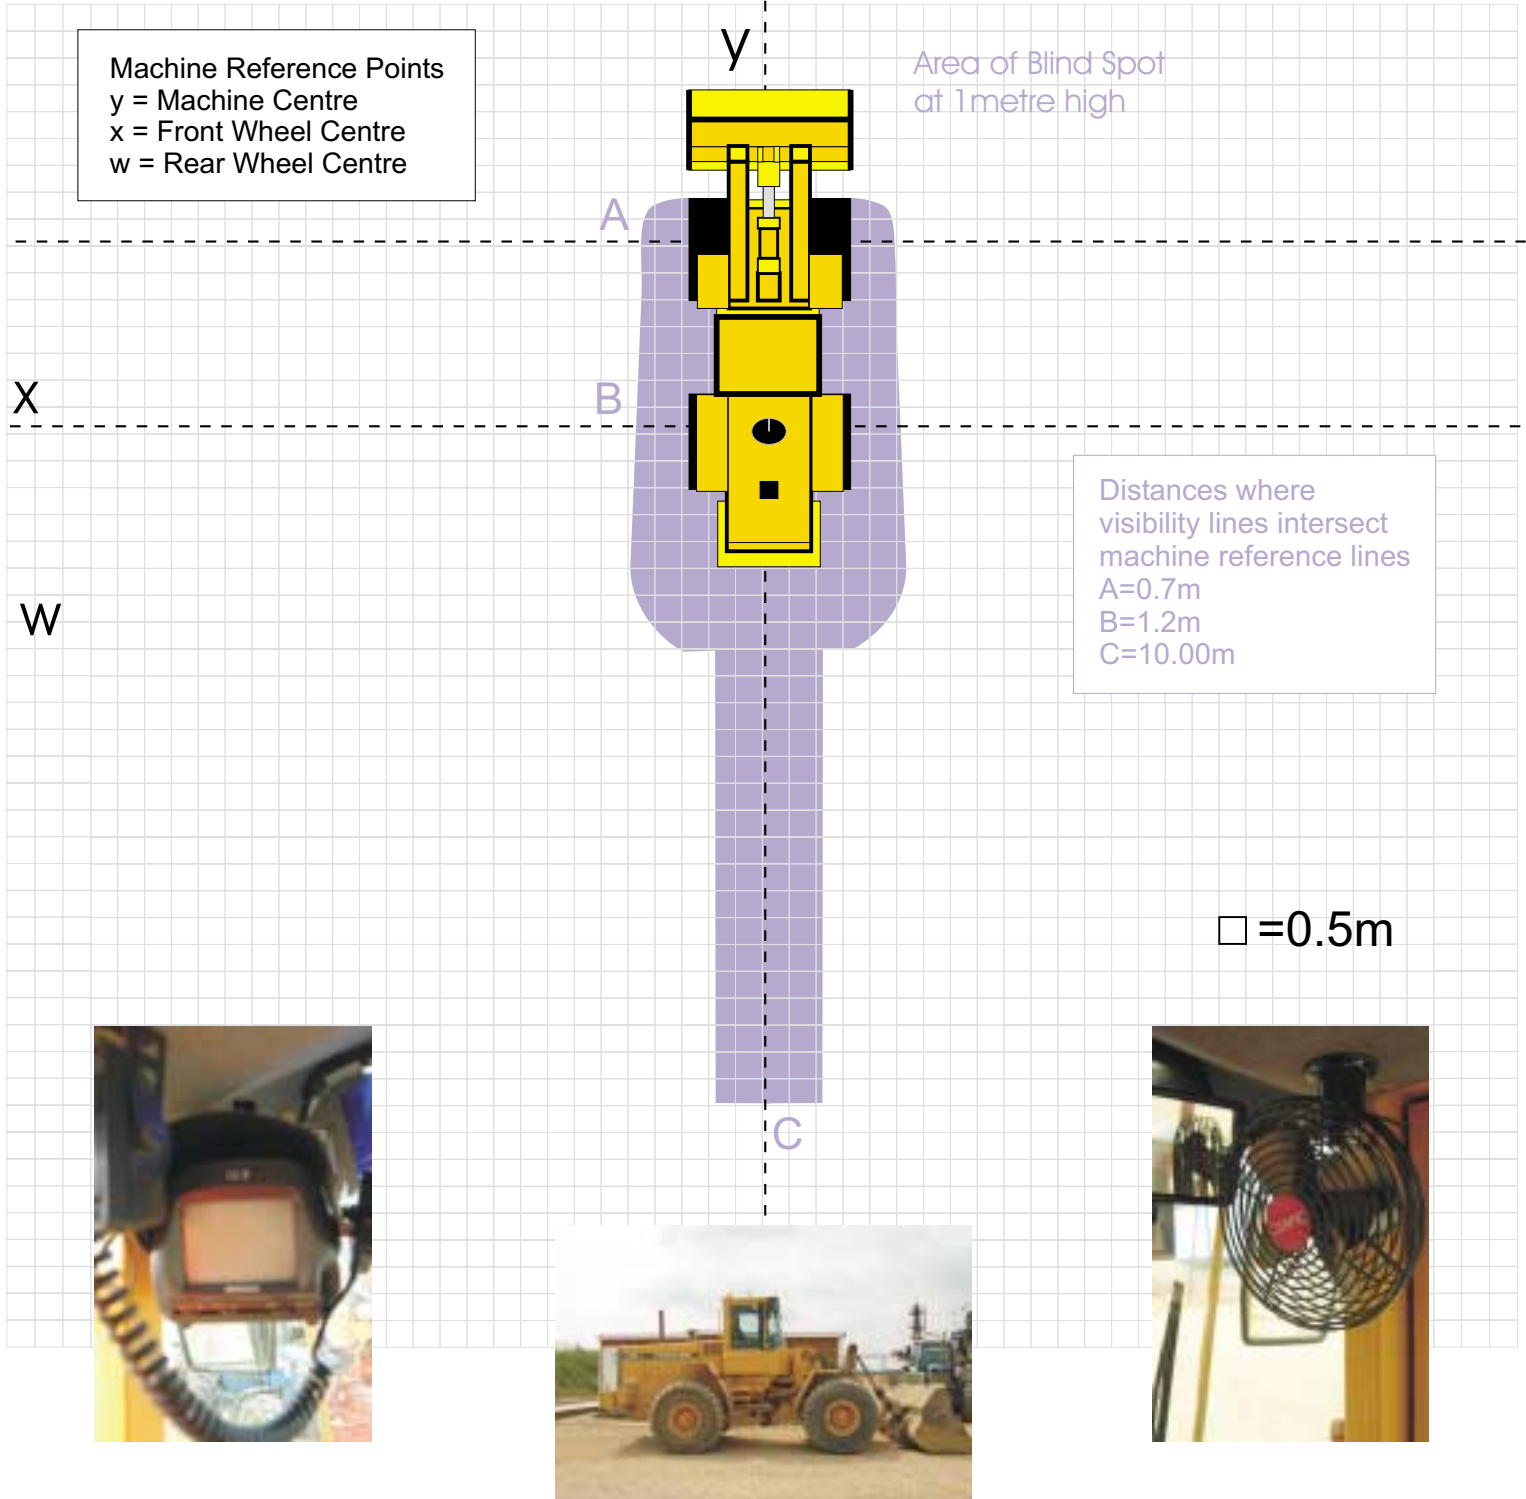
No visibility through mirrors, both obscured

2 x NC100 Convex wing mirrors
 Arms will need extending or adjusting
 to see both flat and convex mirrors
 through obstructions

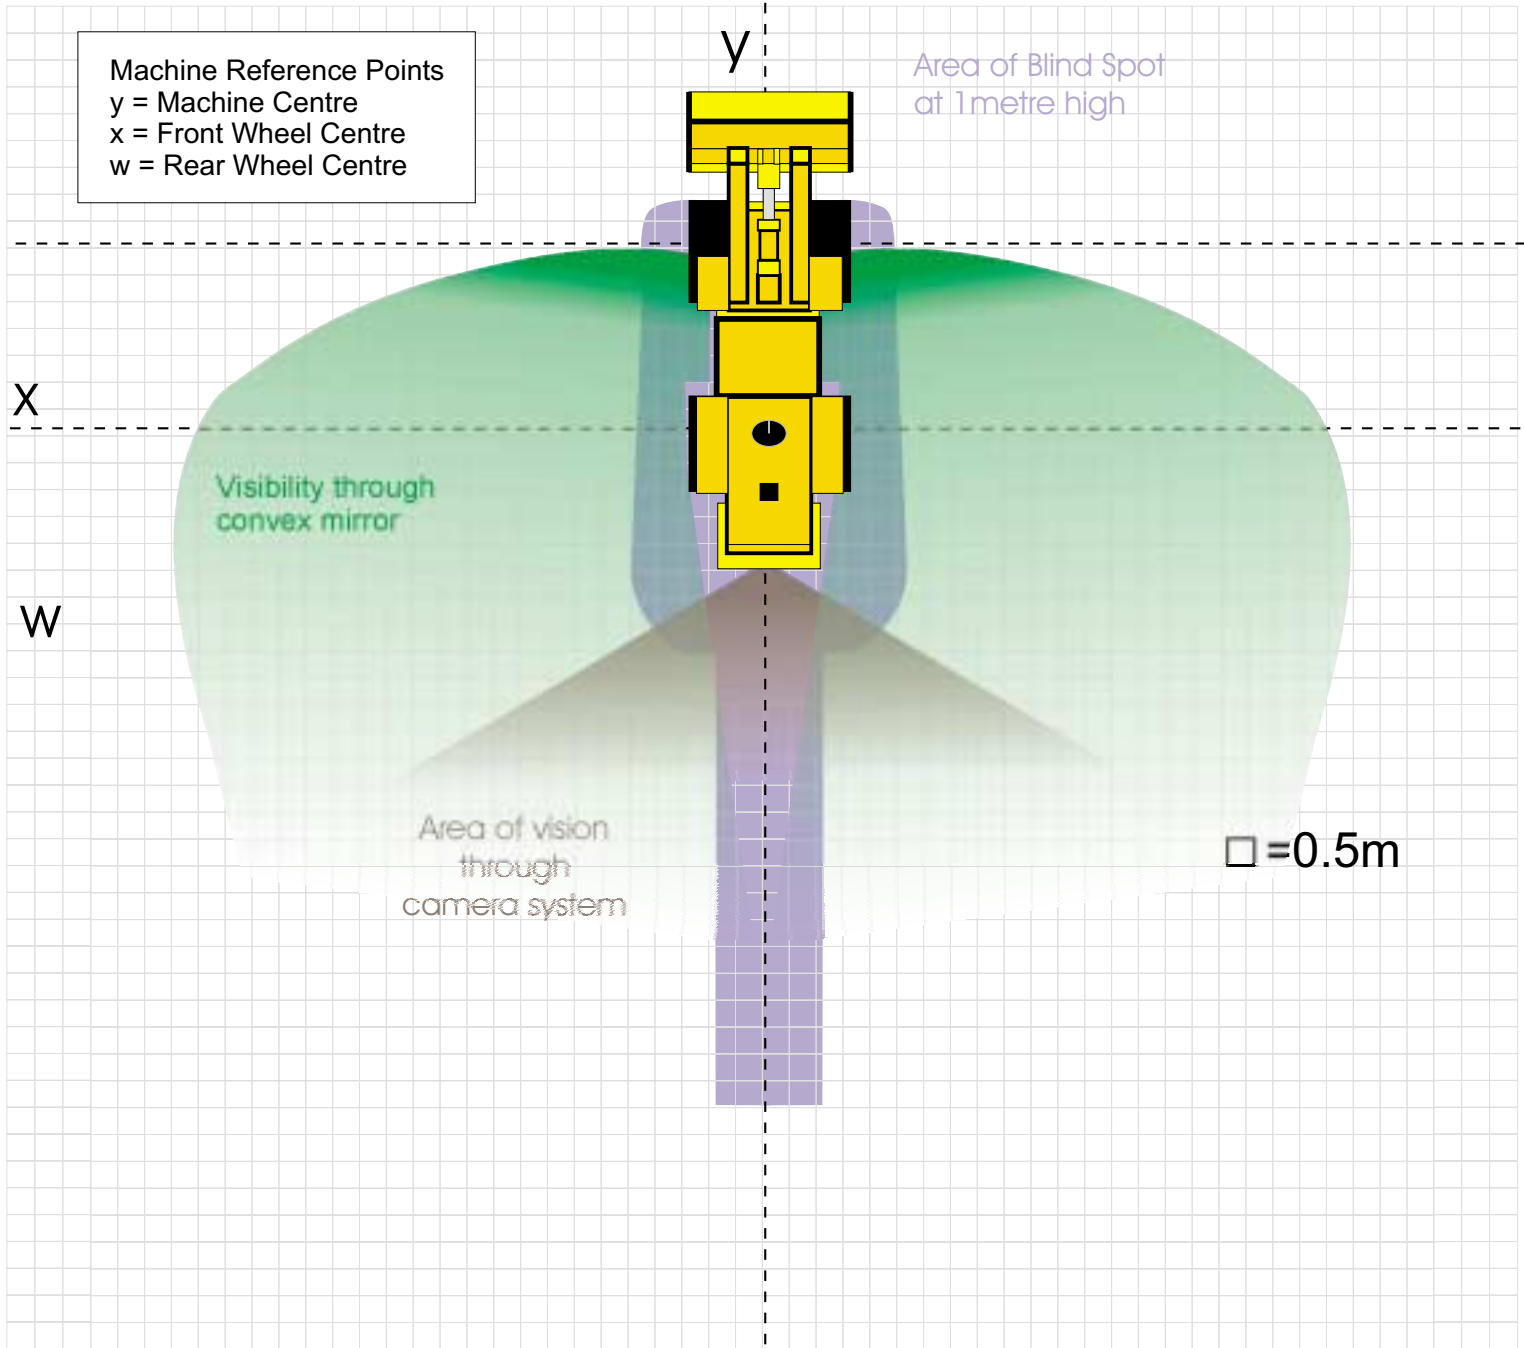
Volvo L180D

Machine Visibility - Enhanced
